# THE MORTAR DAMAGE AND ITS HARMFUL EFFECTS ON THE GLAZED CERAMIC TILES IN TERBANA MOSQUE – ALEXANDRIA, EGYPT

Elshaimaa ABD-ELRAHIM<sup>1</sup> and Ibrahim WESHAHY<sup>2</sup>

This research discusses the damaging factors of the mortar used to affix the glazed ceramic tiles on the walls of Terbana mosque (built in 1685, Ottoman period) in Alexandria, Egypt, and the extension of the damaged impact to the ceramic tiles. This famous, and particularly outstanding mosque with several suspended shops below it, is built in the Delta architectural style, with walls made of limestone blocks and a little red and black adobe for decorative work, a wooden roof and glazed ceramic tiles, with plants and geometric ornaments, adorn parts of the mosque walls.

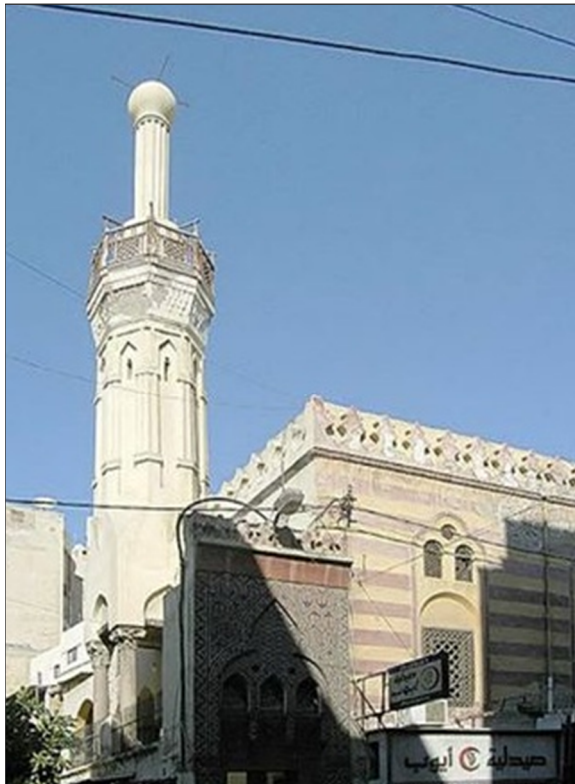
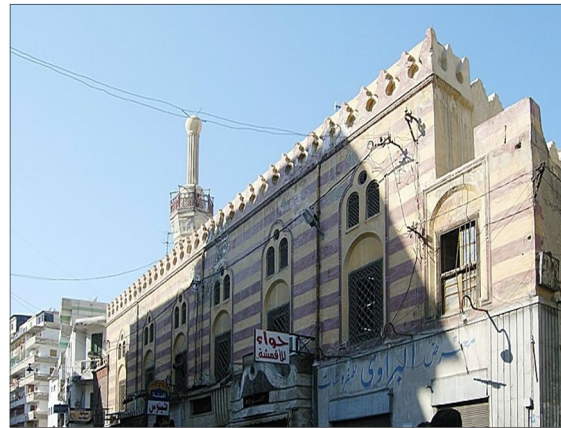
Fig. no. 1a. Terbana Mosque, exterior

Fig. no. 1b. Terbana Mosque, exterior
